# Lake Delhi Dam Reconstruction Design Alternatives Report

Lake Delhi Combined Recreational Facility and Water Quality District

**Final**  
December 21, 2011

## Design Alternatives Report

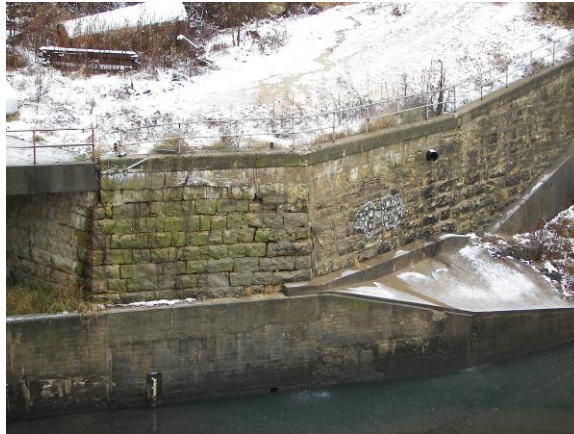
**Downstream North Abutment Wall**  
**Figure 2-1**

- Downstream north abutment wall, upper portion – stone block wall has severely deteriorated.

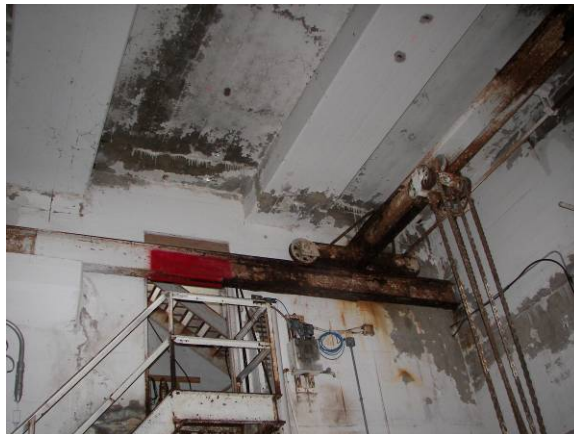
**Powerhouse Roof Seepage**  
**Figure 2-2**

- Significant seepage through powerhouse concrete slab roof was observed.

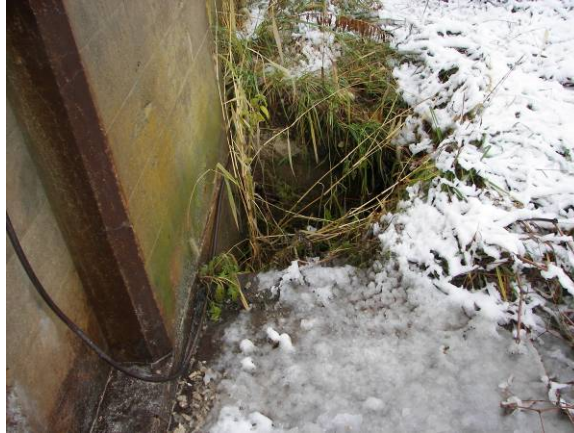
**Material Loss Downstream of North Embankment Wall**  
**Figure 2-3**

- A hole was observed at the front of the downstream north embankment wall. This indicated that the embankment material behind the retaining wall or foundation for the wall may have been eroded by overtopping flows or piping flows.

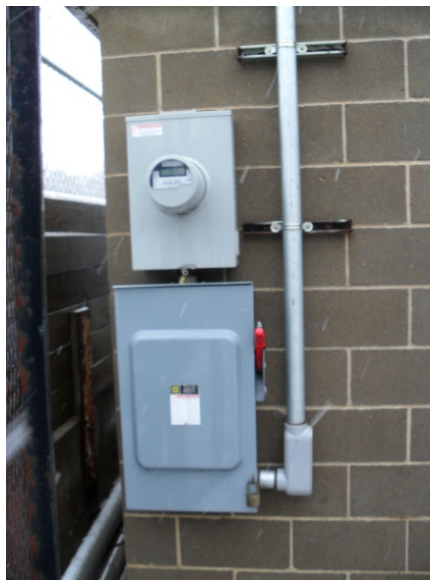
**Meter and Main Service Disconnect**  
**Figure 2-4**

The Lake Delhi Dam is currently served at 480/277V by three pole-mounted transformers located approximately 150 feet north of the powerhouse structure along 230th Avenue. The transformers and existing service drop to the powerhouse are owned by Alliant Energy. The existing utility meter and service disconnect switch, shown in Figure 2-4 below, are located on the north exterior wall of the powerhouse. The meter and disconnect switch are rated for outdoor environments and appear to be in good condition. The overhead service drop conductors also appear to be in good condition.

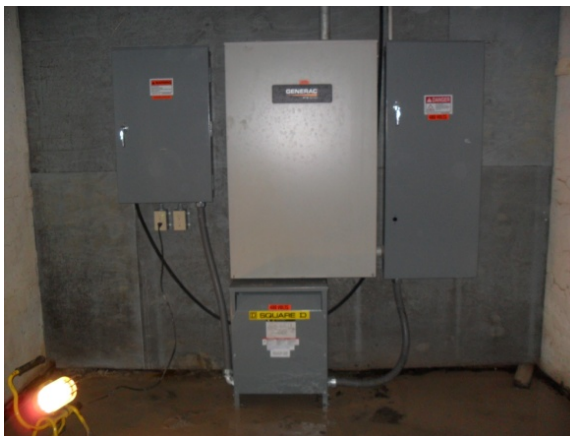
**Distribution Panelboards**  
**Figure 2-5**

This exterior-mounted disconnect switch feeds an enclosed circuit breaker located in the stairwell of the powerhouse. The enclosed circuit breaker provides service to the main 480-volt distribution panelboard (Panel HP), located in the northwest room in the main floor of the powerhouse. A 30-kVA dry-type transformer steps the voltage down to 208/120-volt distribution for lighting and receptacle circuits in the powerhouse. A 208/120-volt distribution panelboard (Panel LP) is located next to panel HP and the step-down transformer. Figure 2-5 shows panel HP (right), the step-down transformer and panel LP (left). Also shown is an automatic transfer switch (center) not currently connected to the system.

The automatic transfer switch, panelboards, step-down transformer, enclosed circuit breaker, meter and service disconnect switch were installed within the last couple of years to update the electrical service to the dam to 480/277-volts. Prior to the installation of this equipment, the dam was served at 208/120-volts. The panelboards were both installed in NEMA 3R weatherproof enclosures and do not appear to have any water damage due to the flooding.

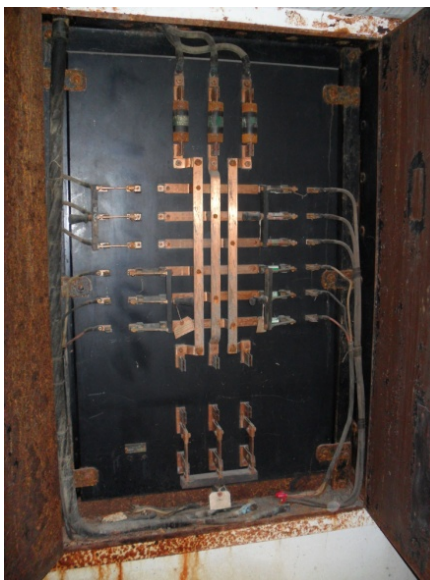
**Outdated Fuse Box**  
**Figure 2-6**

All of the distribution equipment from the disconnected 208/120-volt system is still present in the powerhouse, including two outdated fuse boxes and a distribution panelboard with no cover plate. One of the outdated fuse boxes is shown in Figure 2-6.

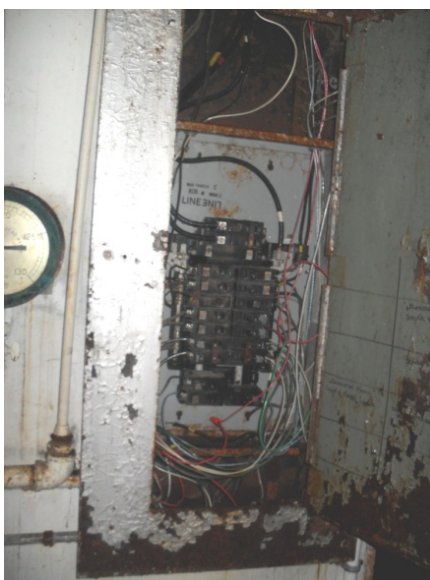
**Distribution Panelboard with No Cover Plate**  
**Figure 2-7**

The lighting and receptacle circuits in the powerhouse are being fed from the new panel LP at 120-volts. Prior to installation of the 480-volt service, these circuits were fed from the distribution panelboard with no cover plate. This panelboard is now being used as a junction box in order to utilize existing wiring in the facility, but to provide power from the new panel LP. The existing distribution panelboard with no cover plate is shown in Figure 2-7.

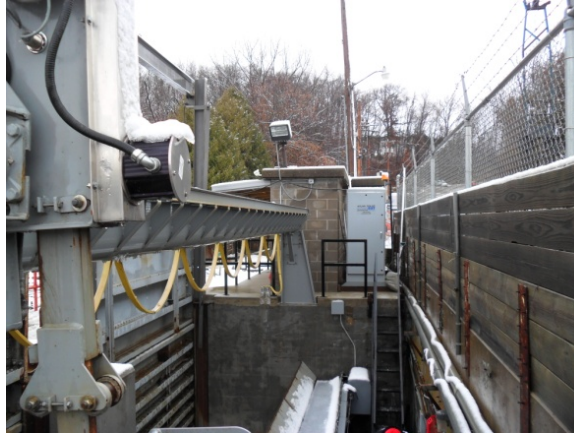
**Trash Rake Equipment**  
**Figure 2-8**

The trash rake equipment, located on the top of the powerhouse structure, does not appear to have suffered significant water damage during the flooding. The PLC control cabinet does not have any indication of water damage; however, the conveyor equipment was underwater and may be damaged from the flooding. Figure 2-8 shows the existing trash rake system and trash rake PLC control cabinet.

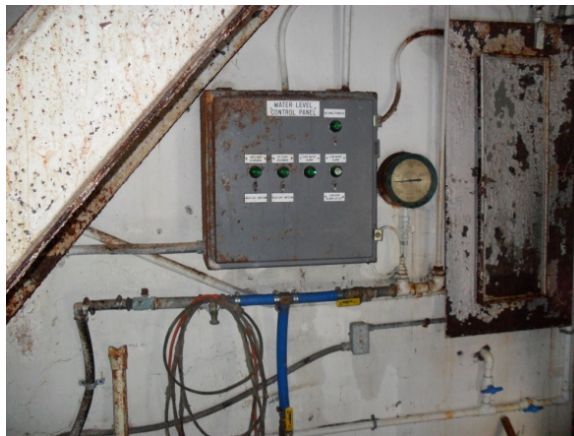
**Water Level Control Panel**  
**Figure 2-9**

There does not appear to be any electrical equipment for pool level monitoring. There is an existing control panel, shown in Figure 2-9, labeled as 'Water Level Control Panel', which appears to have been used in conjunction with the hydroelectric generation equipment. There were not any field instruments observed in operation with this control panel.

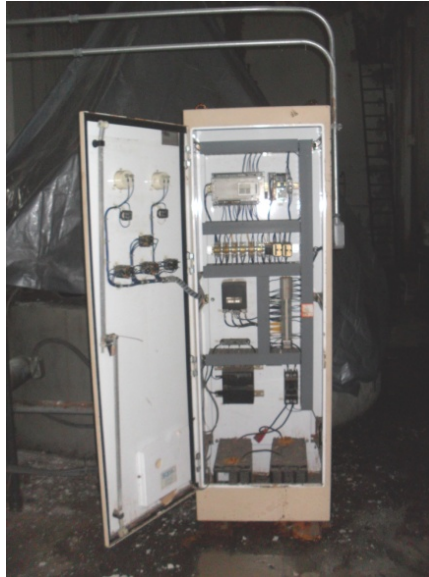
**Hydroelectric Generator Control Panel**  
**Figure 2-10**

The existing hydroelectric generation equipment is not operational. The control panels for each hydroelectric unit were inundated with water during the 2010 flood event and significant damage was observed to the battery systems and electronic control devices. Figure 2-10 shows one of the hydroelectric unit control panels. The main PLC cabinet for the hydroelectric system is located on the wall in the generator room and was also damaged by water during the flood event.

Each hydroelectric generator control panel also provides power to the associated wicket gate actuators. Currently, the wicket gates are operated manually, as the control system for the hydroelectric equipment and wicket gates are non-operational.

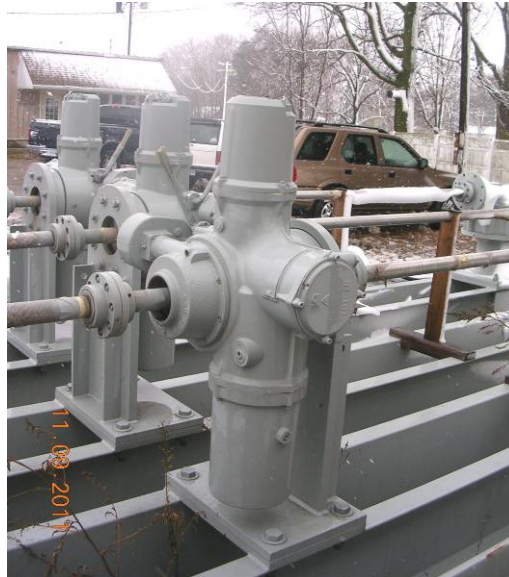
**Figure 2-11**

There are three existing vertical Broome Gates that are original from 1927. During the 2010 flood, one of them did not open completely because the guide in the dam had deteriorated. The cable and drum hoist mechanisms for raising the gates had been recognized as needing replacement. Prior to the flood, the Owner purchased and received new electric motor driven screw actuators for the three existing gates, shown in Figure 2-11. The three existing gates, and gate guides at the dam need to be replaced for the gate system to function adequately.

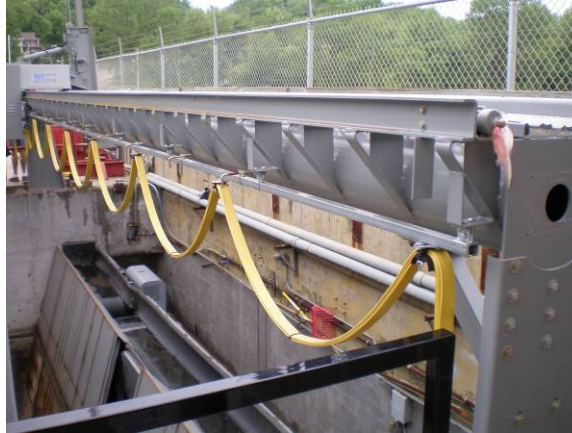
**Trash Rake**  
**Figure 2-12**

The HydroRake was installed in 2009 to remove the trash that accumulated on the two bar screens protecting the wicket gates. The raking system consists of two bar screens with a hydraulically operated trash raking arm mounted on a traveling chassis that discharges onto belt conveyors that remove the trash to the discharge of the spillway gates. The flood inundated this equipment except for the PLC control cabinet. To make this system operational again, a complete inspection of the equipment is required. At a minimum, the motors would need to be replaced, the local switches and sensors would need to be replaced, the submerged wiring would need to be replaced, and the hydraulic oil would need to be flushed. The belts, bearings, rollers, and hydraulic motor would need to be inspected, oiled, greased, or replaced as necessary. The trash rake is shown on Figure 2-12.
